OPERATING EXPERIENCE WEEKLY SUMMARY

Office of Nuclear and Facility Safety

August 6 - August 12, 1999

Summary 99-32

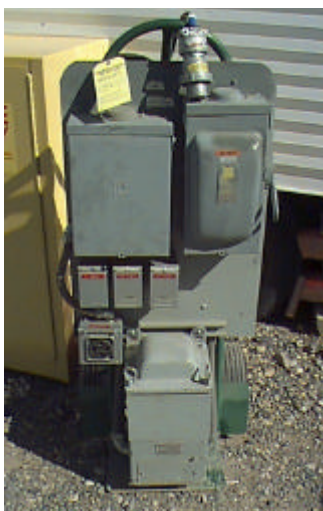
Figure 1-1. Temporary Power Supply Panel

On August 9, 1999, at the Idaho National Environmental Engineering Laboratory Test Reactor Area, a plant utility operator received an electrical shock from a temporary power supply panel that was plugged into a permanently installed 480-V ac receptacle. The shock occurred when the operator touched a permanently installed conduit that contained 115-V ac while touching the temporary panel. Site medical facility personnel examined the operator and determined that he was not injured. The temporary panel belongs to a construction contractor and is used to transform 480-V ac to supply a variety of voltages to several outlets on the panel. Plant electricians determined that the plug on the temporary panel was miswired, causing the panel case to be energized with a 277-V ac potential to ground. They tagged-out the temporary power supply panel and removed it from the building. Unidentified electrical hazards have the potential to cause injuries or a fatality. (ORPS Report ID--LITC-TRA-1999-0022)

Investigators determined that the facility did not have a 220-V ac outlet, so construction personnel used the temporary power supply panel to reduce power from 480 V ac when performing 220-V ac welding activities. Site procedures require the temporary power supply panel to be inspected by an electrical subcontractor every 6 months. Investigators determined that this temporary panel was successfully inspected in June 1999. However, in July construction personnel loaned the panel to an off-site construction contractor. The construction contractor personnel who borrowed the panel told investigators they had changed the plug to a four-prong plug for their use, then changed it back to a three-prong plug before returning the panel. Investigators determined that the off-site contractor personnel incorrectly connected the ground wire to one of the phases when they reinstalled the three-prong plug. Figure 1-1 shows the temporary power supply panel.

there were no administrative controls requiring personnel to maintain exclusive control of portable equipment or to reinspect it if it had not been controlled since the last inspection. The facility manager determined that facility personnel may be unaware of modifications made to equipment loaned to other contractors and may not understand that these potential modifications could affect equipment operating capabilities as well as personnel safety. The facility manager will develop corrective actions as necessary.

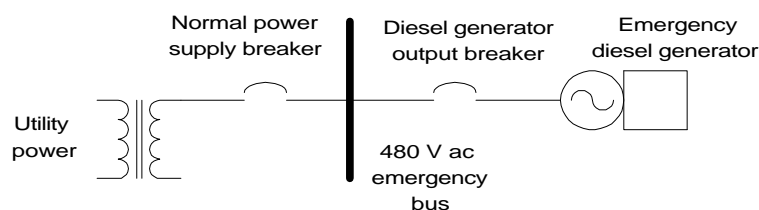
Figure 5-1. Simplified Emergency Power Scheme

On July 22, 1999, at the Savannah River F-Canyon Facility, an emergency diesel generator output breaker failed to open in response to a trip signal following a load test to verify the operability of protective relays. The generator motored for approximately 3 hours while facility operators and engineers investigated the trip failure and evaluated recovery methods that would not impact power to vital loads. An operator tripped the output breaker mechanically at the breaker front as another operator prepared to manually isolate fuel to the diesel engine, if

Figure 5-1 is a simplified diagram of the emergency power scheme. The load test consists of simulating a power outage to the emergency bus and verifying the ability of the diesel generator to start, pick up load, and maintain emergency loads. At the end of the test, utility power is paralleled with the diesel generator through the normal power supply breaker, and emergency bus load is gradually transferred from the diesel generator to utility power. When generator load is reduced to 300 amperes, the operator presses a STOP button on the generator control panel, sending an electric trip signal to the control logic for diesel generator output breaker and shutting down the diesel by tripping the fuel racks. However, when the operator pressed the STOP button, he noticed that the diesel generator output breaker did not open, and the diesel generator continued to run. He also noticed that the generator ammeter indicated 285 amperes, and the generator power meter indicated zero.

The failed breaker, a Brown Boveri Model LK20, is equipped with auxiliary switch contacts in series with a breaker trip coil that energizes to trip the breaker. The contacts close when the breaker closes to align the trip coil to electric trip circuits and are operated mechanically by the breaker mechanism. Troubleshooting revealed that these contacts were not closed while the breaker was closed. Consequently, the breaker failed to trip, although all upstream logic (manual trip, lockout, and reverse power) operated normally.

Investigators determined that the diesel fuel racks tripped as required and the generator had been motoring from the time that the operator pressed the STOP button. Facility personnel determined that the auxiliary contacts failed to close properly because they were dirty.

necessary. Maintenance personnel removed the breaker to inspect it. They also inspected the generator and diesel for damage and replaced the diesel fuel injectors because they showed signs of wear. However, engineers do not believe that the wear was caused by the motoring event. Facility personnel retested the diesel generator and output breaker and placed them back in service on July 28. This occurrence is significant because generator motoring can cause significant damage to electrical generating equipment. (ORPS Report SR--WSRC-FCAN-1999-0019)
